Technical Report CERC-95-17  
October 1995

# **Noyo Harbor, California, Breakwater Stability and Transmission Tests**

U.S. Army Corps of Engineers  
Waterways Experiment Station  
3909 Halls Ferry Road  
Vicksburg, MS 39180-6199

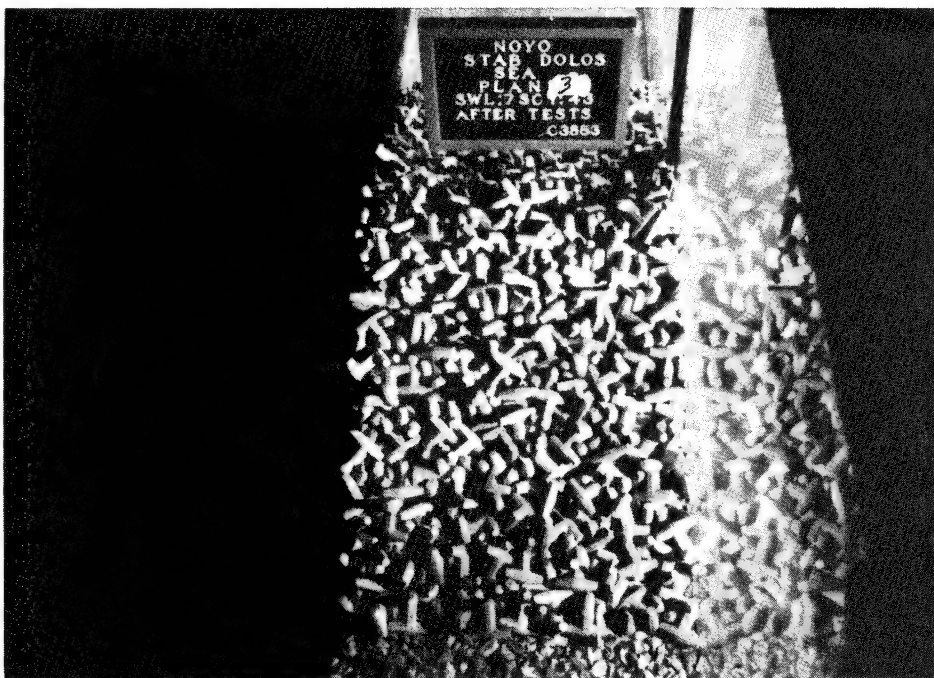
Photo B16. Plan 3, Seaward view, after testing

Photo B17. Plan 3, Leeseide view, after testing

After the structure was subjected to the conditions in Table 3, 1.6 percent of the units were displaced on the sea side (Photos B16 and B17). The structure did not reach a damaged condition and a  $K_d$  of 29.8 was calculated. However, eight units were observed to rock in place during original tests and ten units rocked in place during repeat tests. This movement of units indicates that units would break on the prototype structure, which could result in failure of the structure. Quantitative and qualitative results indicated that Plan 3 was moderately stable for the design wave conditions conducted at +2.13 m mllw. No stone was displaced from the toe berm.
